SKAGIT COOPERATIVE WEED MANAGEMENT AREA
Upper Skagit Knotweed Control Program
2015 Season Ending Report
10/06/2015

Prepared by:
Michelle Murphy
Stewardship Manager
Skagit Fisheries Enhancement Group
PO Box 2497
Mount Vernon, WA 98273

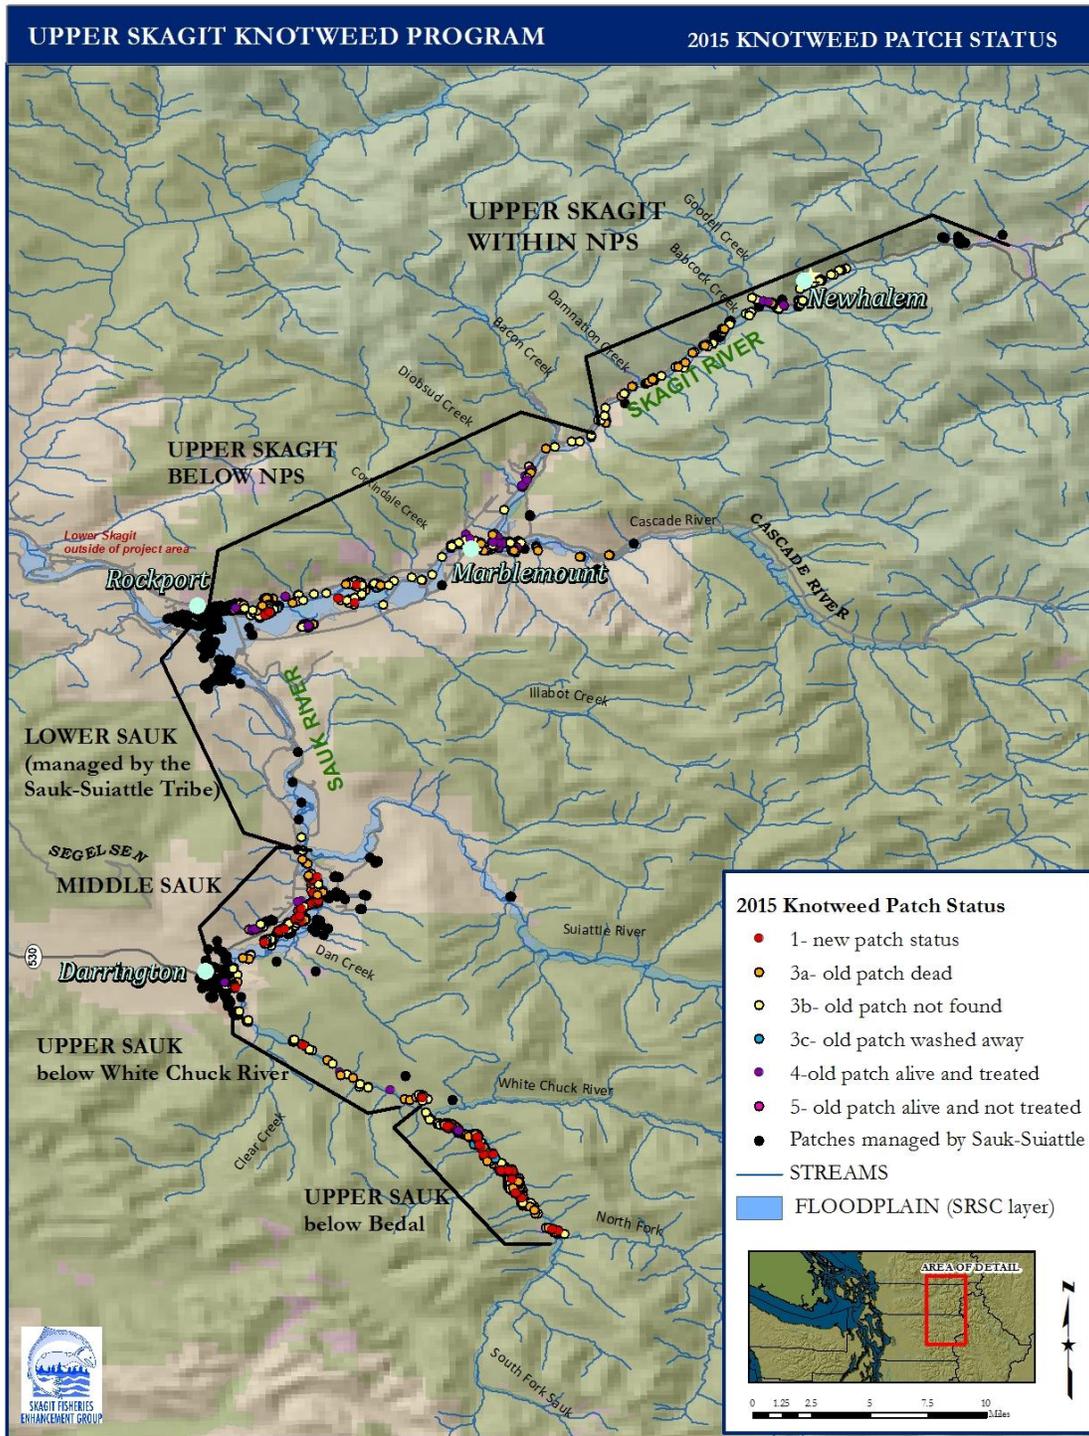
Figure 3. This figure shows the GIS/GPS data used to record and track knotweed patch data, and visually depicts where patches are eliminated, not visited, etc. Patches not visited (in pink) that are located higher in the watershed, e.g., above Marblemount or near Darrington are upland patches out of the floodplain that were not given high priority in the prioritization strategy. Shown in black are patches that were monitored by the Sauk-Suiattle Indian Tribe in 2015. Note the floodplain GIS layer used for this map and others in this report was developed by the Skagit River System Cooperative (SRSC) for the Skagit Chinook Recovery Plan (2005).

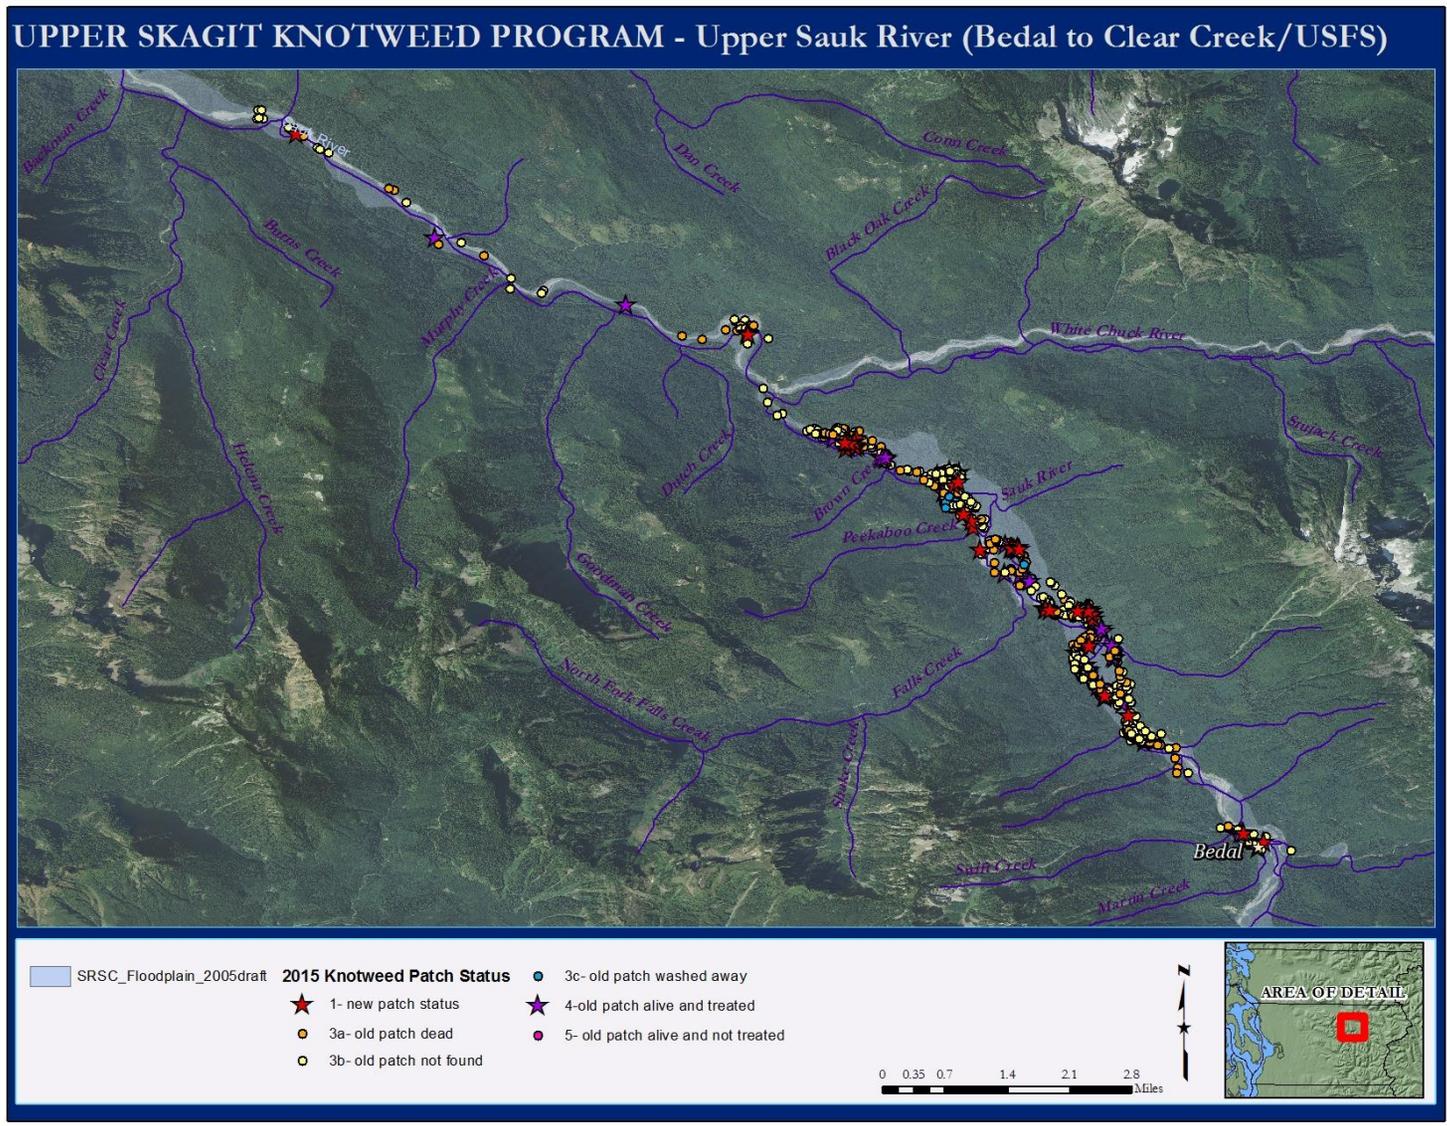
Figure 5. Knotweed patch distribution in 2015 on the upper Sauk River.

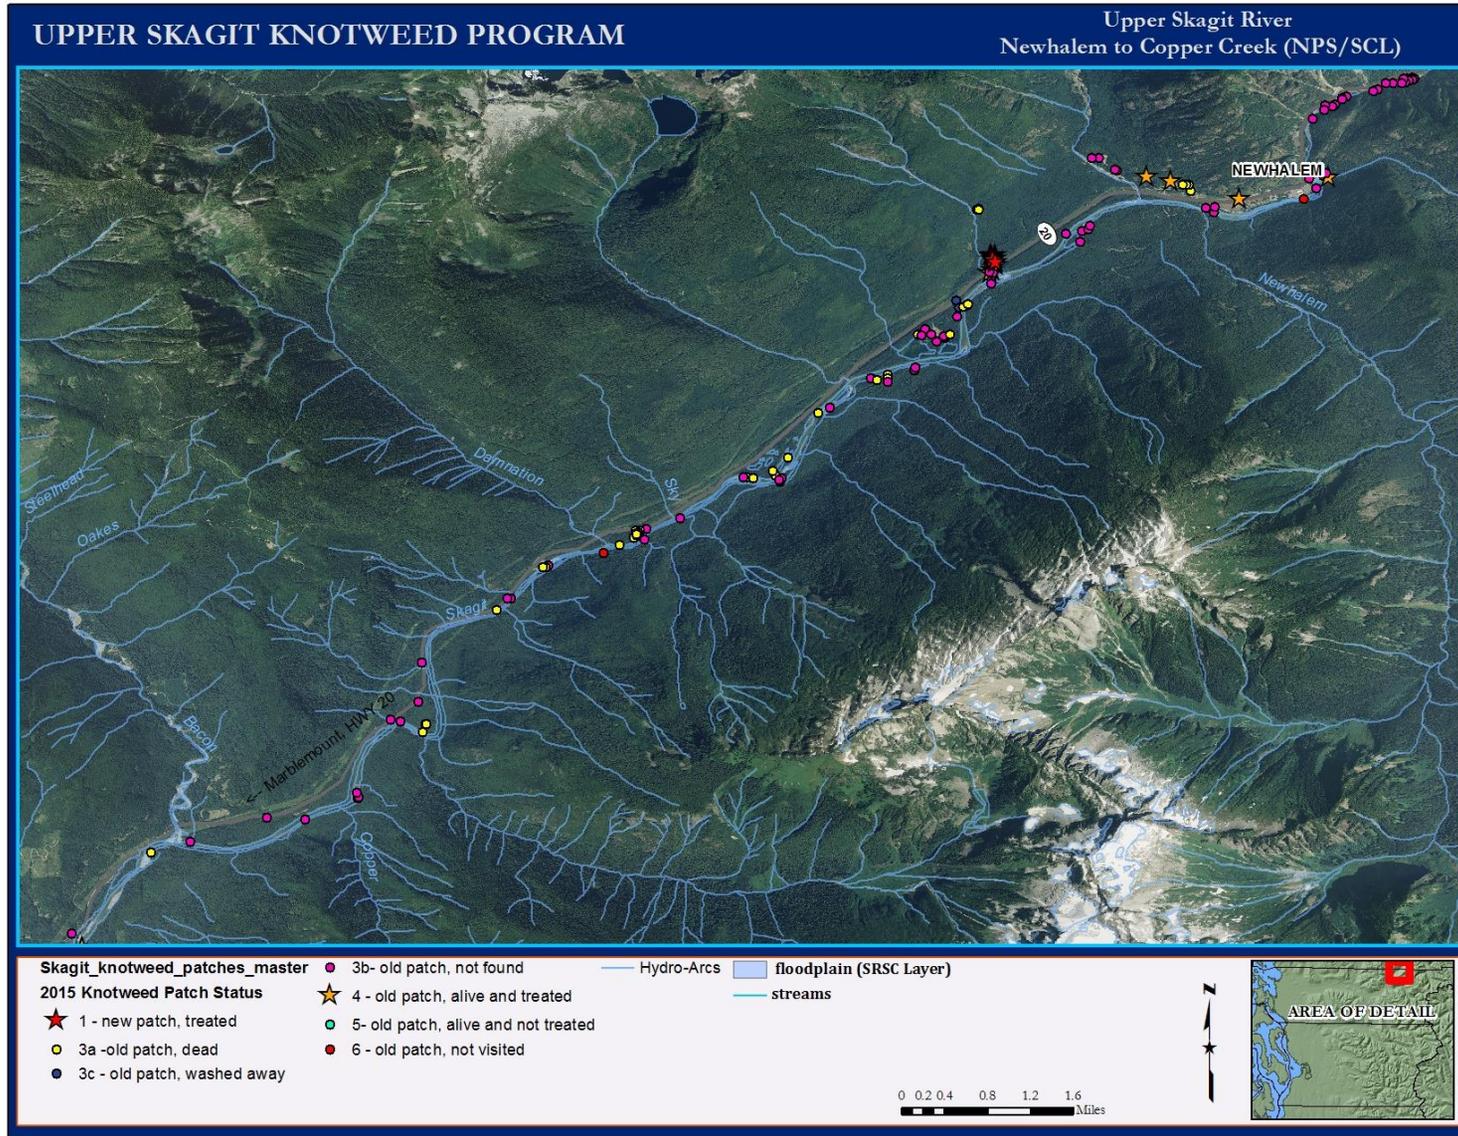
Figure 7. Knotweed treatment in the upper Skagit subbasin.

Highlights for the Upper Skagit River subbasin are listed below and depicted in Figure 7.

- 147 patches found from Diablo to Copper Creek since 2001.
- 5 new patches found, all on Babcock Creek.
- 8 old patches alive found in Newhalem and Babcock Creek.
- 95% of patches eliminated since project started, this is the percentage of dead or not found patches in the total project area above Copper Creek, this calculation does not include new patches found (up from 93% in 2014). If we include new patches the percent elimination is 91%.
- 100% of live patches found were treated.

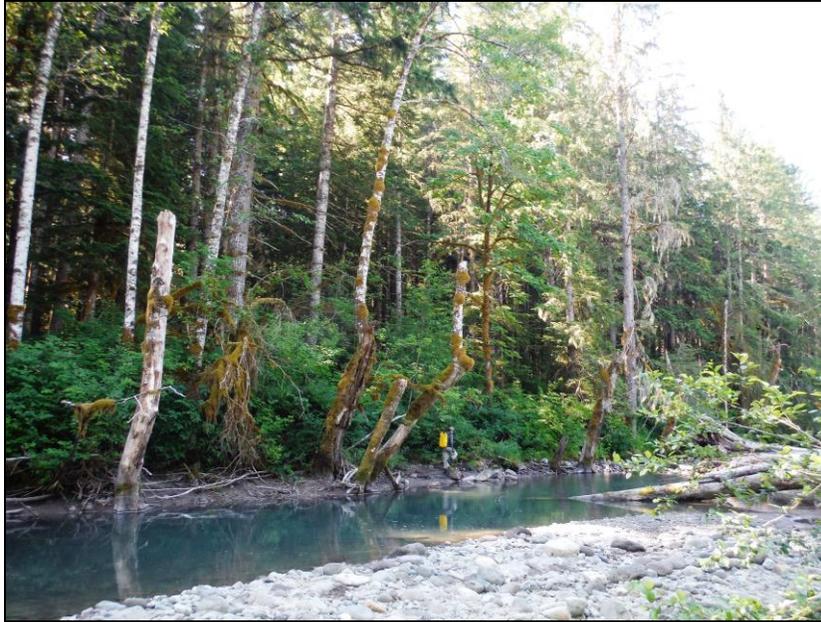
Figure 8. WCC Crew surveying a side channel of the Sauk River, above the White Chuck River on USFS land. Backchannels are the most common place new knotweed patches are found and can be difficult to locate and survey. These small patches can be difficult to locate and are one of the challenges in controlling knotweed on the upper Sauk.

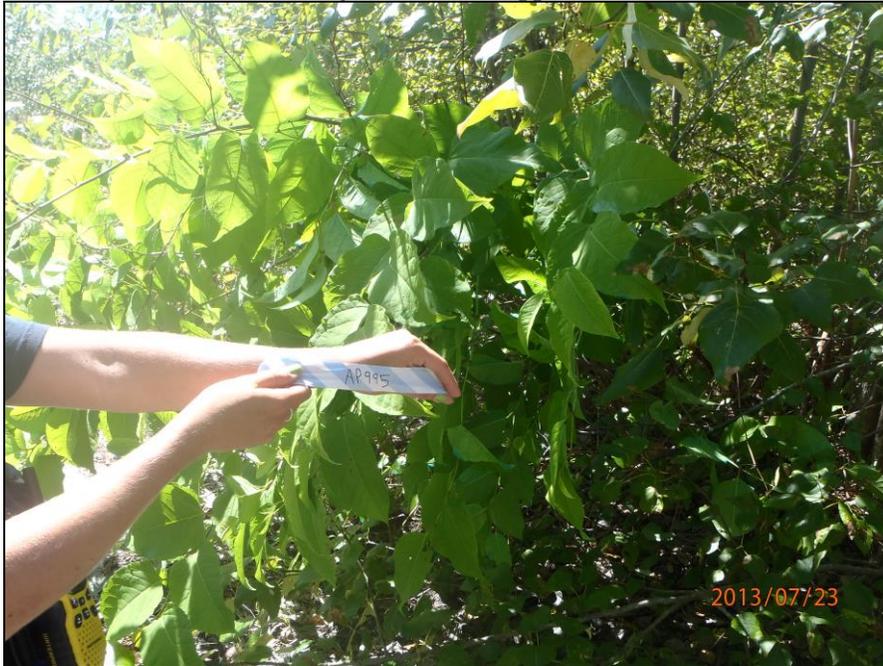
Figure 10. Before: Patch AP995 found on the upper Sauk in 2013, with 5 stems.

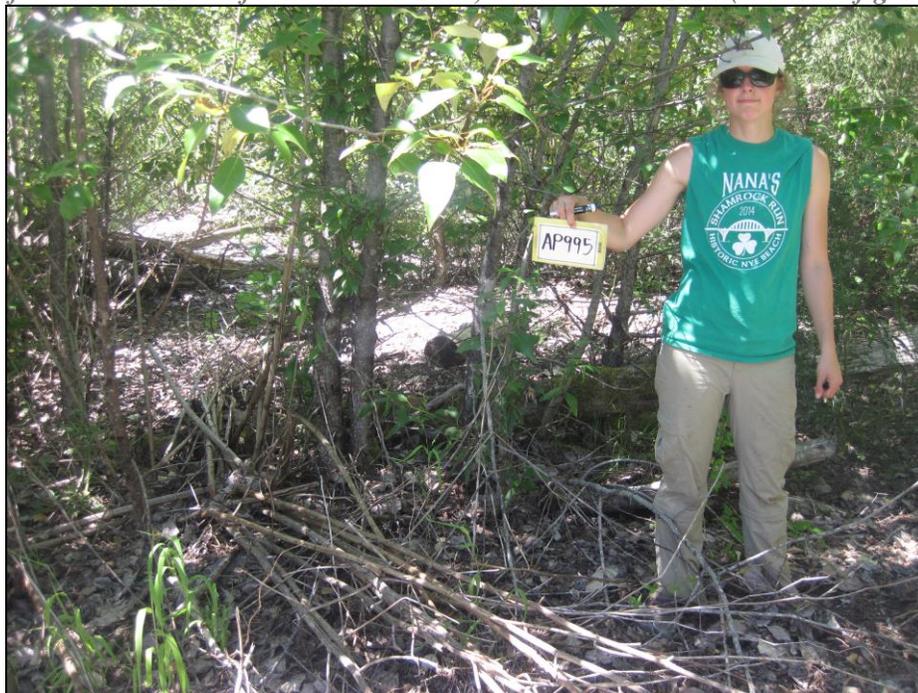
Figure 11. After: Patch AP 995 found dead in 2015, was treated in 2014 (shown in figure13).

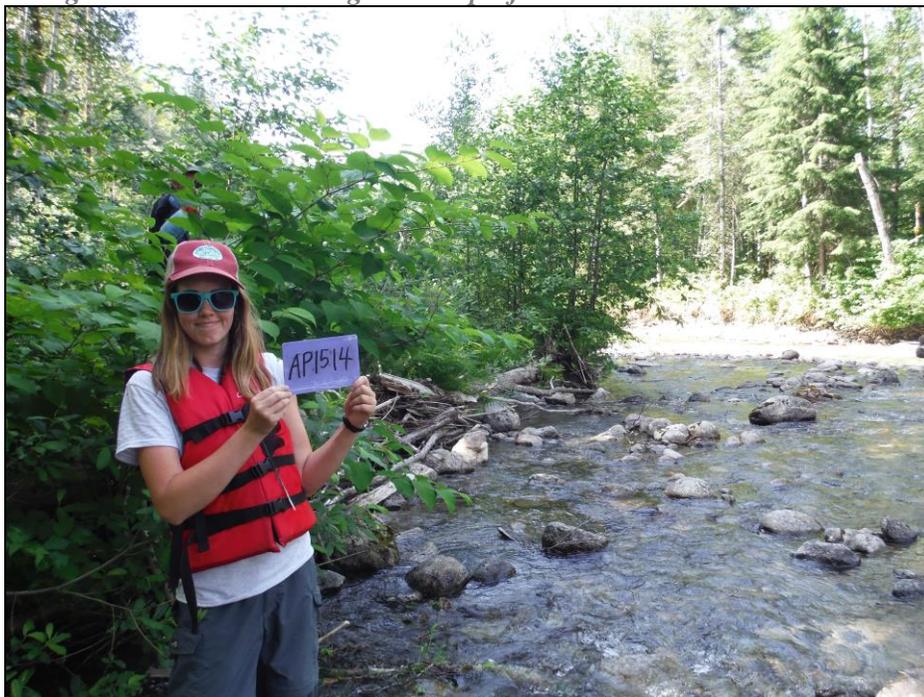
Figure 12. New Patch AP1514, found on the mainstem Sauk River. It is very uncommon to find large patches like this along the mainstem river edges in the project area.

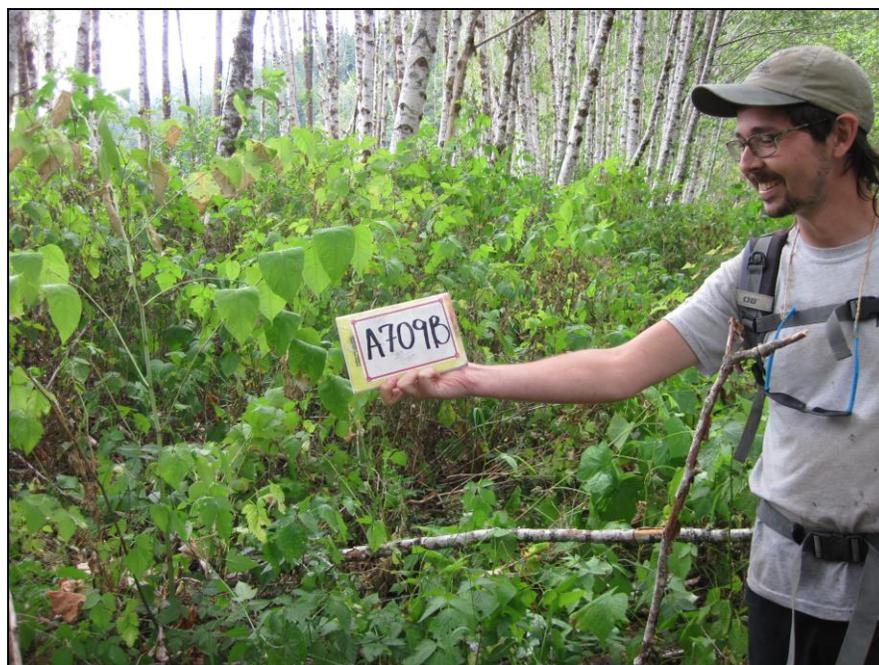
Figure 13. Old patch A709B was found in the understory of a back channel of the Upper Sauk. It is not uncommon to find knotweed patches growing in the understory of the floodplain. This patch represents a major problem with knotweed which is that after several years of being found dead (in this patches case 2013 and 2014) it resprouted in 2015, again supporting the method of resurveying for all patches each year.

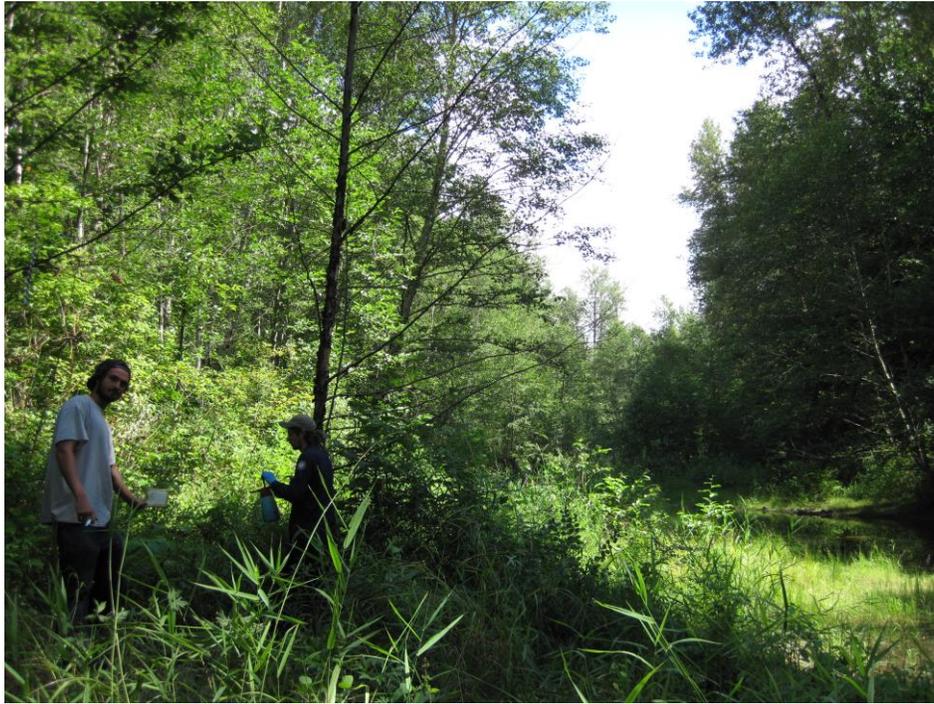
Figure 15. Before: AP1229 along a side channel of the Middle Sauk River found alive with several stems in 2015.

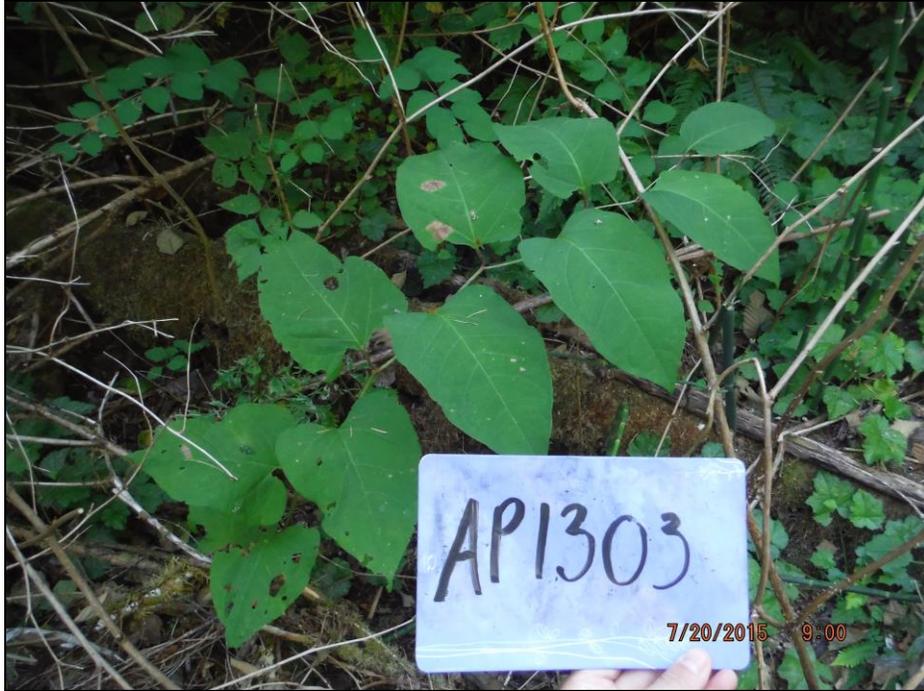
Figure 17. Patch AP1303, was first found in 2013 with 50 stems and treated, then found with 10 stems in 2014 and found alive again in 2015 with 1 stem. This patch demonstrates the sometimes slow progress of treatment, these single remaining stems in the understory can be difficult to find at times. However it is important to note that some patches do die after 1 treatment.

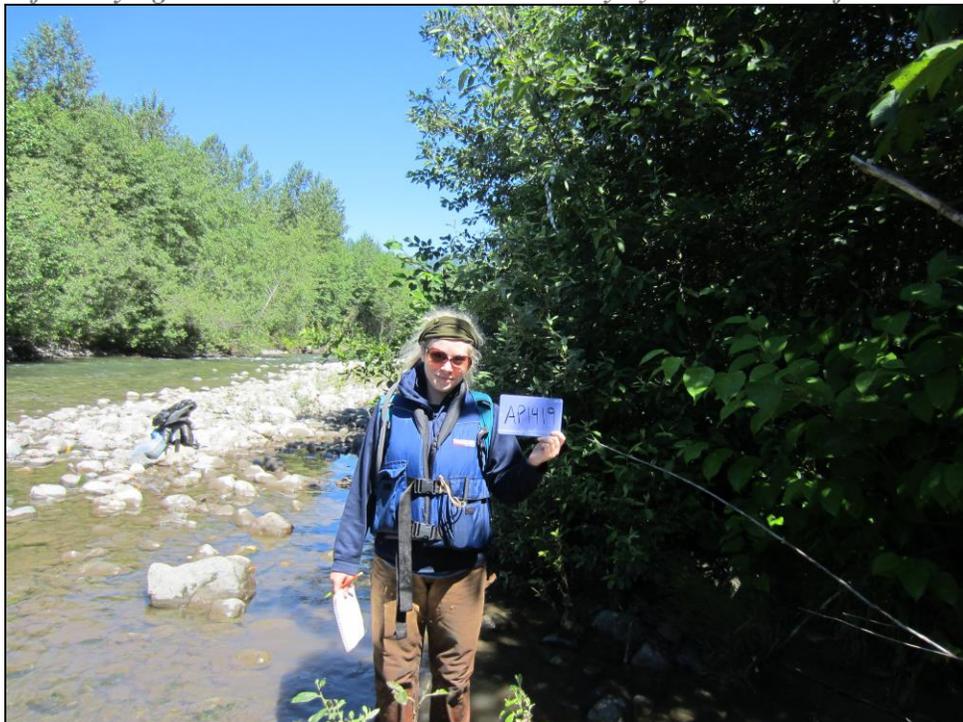
Figure 18. Photo taken July 2014: Patch AP1419, was found and treated in 2014 on a side channel of the upper Sauk River. In 2015 the Sauk River shifted course and this side channel became the mainstem of the Sauk River and the location of this patch was under water this field season. This patch represents the importance of surveying side channels and illustrates the very dynamic nature of the Sauk River.

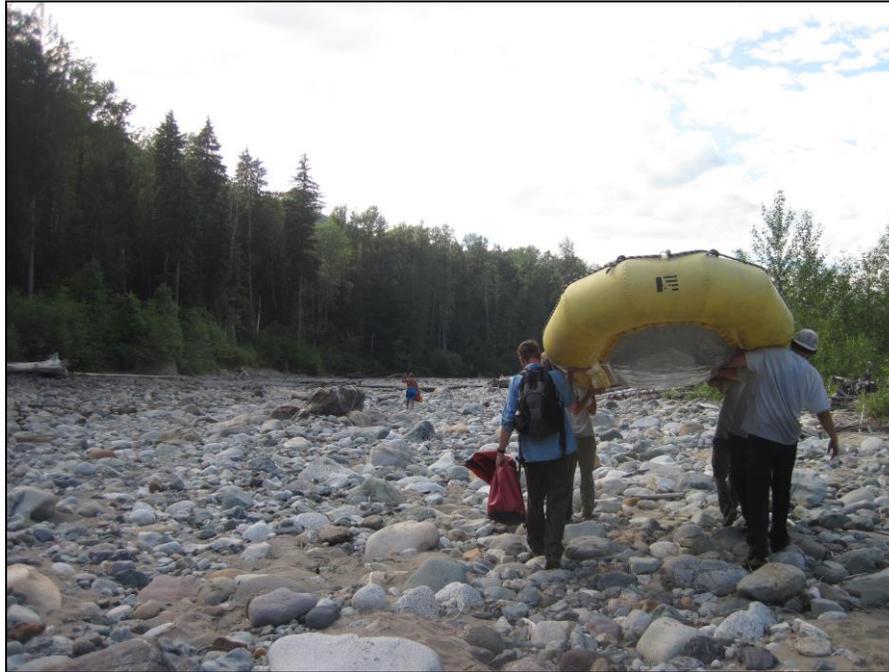
Figure 19. Shown in the photo, a section of the Sauk River mainstem, dry in June of 2015. Due to drought conditions and shifting channels sections of what was in 2014, the mainstem of Sauk River were dry this season. This made for an interested knotweed season as rafts had to be portaged across a mile of dry river bed and access routes from the road had to be found to reach the floodplain for surveys. One positive part of these dry conditions was that they allowed crews access to new sections of the floodplain while surveying.

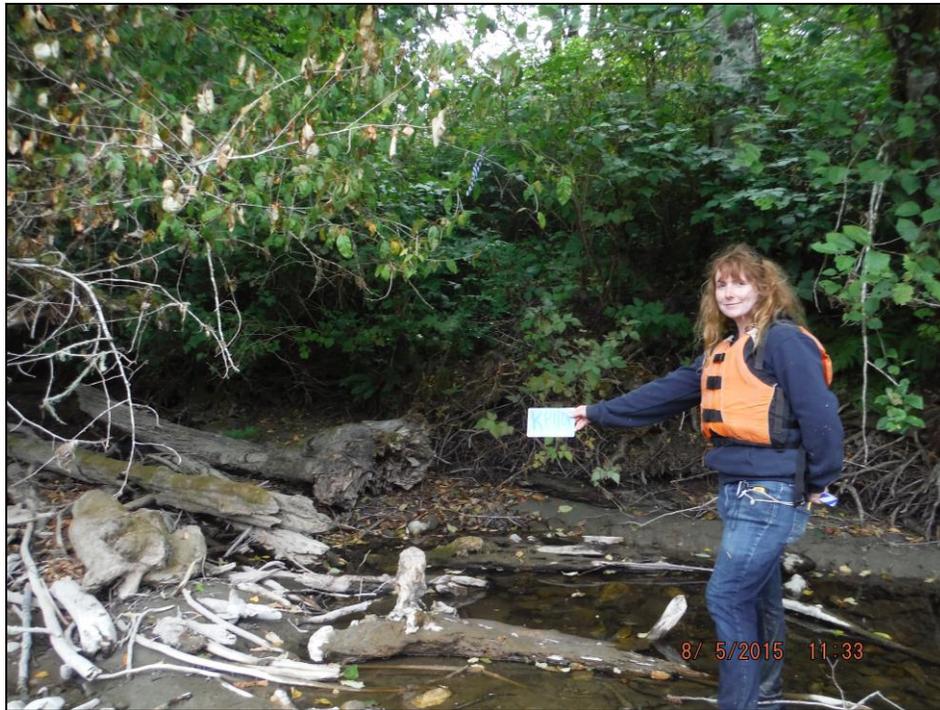
Figure 21. Patch KP1119 is located on USFS land below Copper Creek on the Skagit River. It was found dead after treatment in 2014, only 3 patches were found alive during 2015 survey on this section of river (Copper Creek to Marblemount).

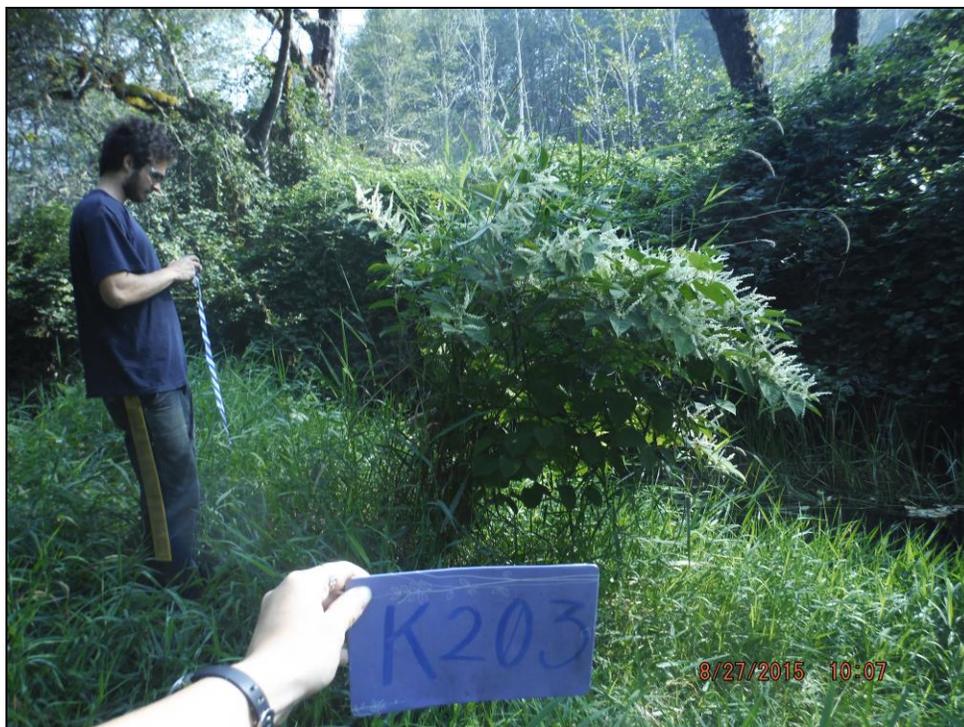
Figure 23. Patch K203 is on a side channel of the Skagit below Illabot Creek. Note WCC crew member preparing to hang blue and white patch ID flagging. These flags are hung to identify all patches.

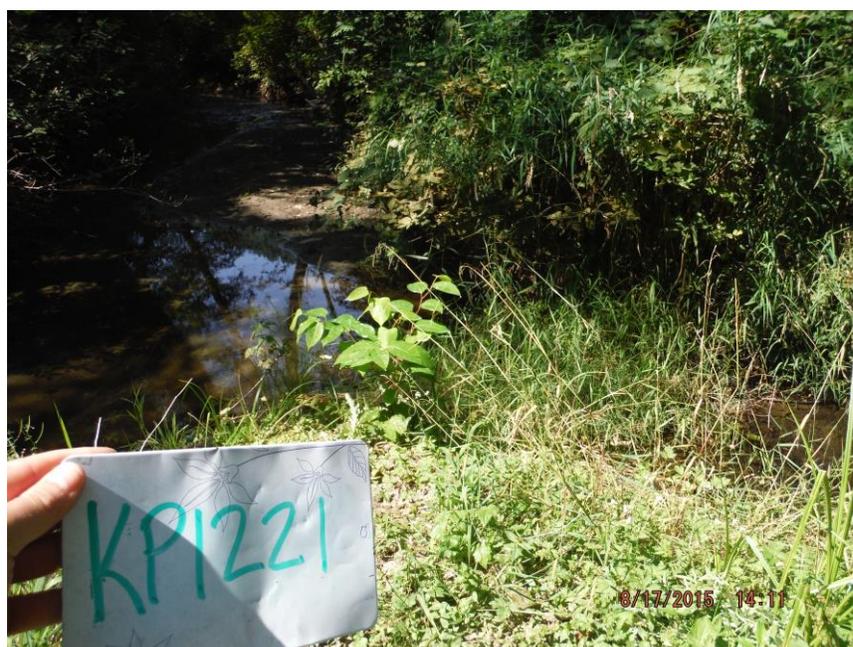
Figure 24. KP1221 was found in 2012 densely infesting a side channel of the Skagit, this patch was part of a complex of patches found on this side channel. In 2012 this patch had 40 stems, 2013, 1, 2014 none then 7 in 2015. Patches larger than 10 stems take diligence to find very small re-sprouts several years after treatment. The complexity of regrowth patterns is one of many control challenges in controlling knotweed.

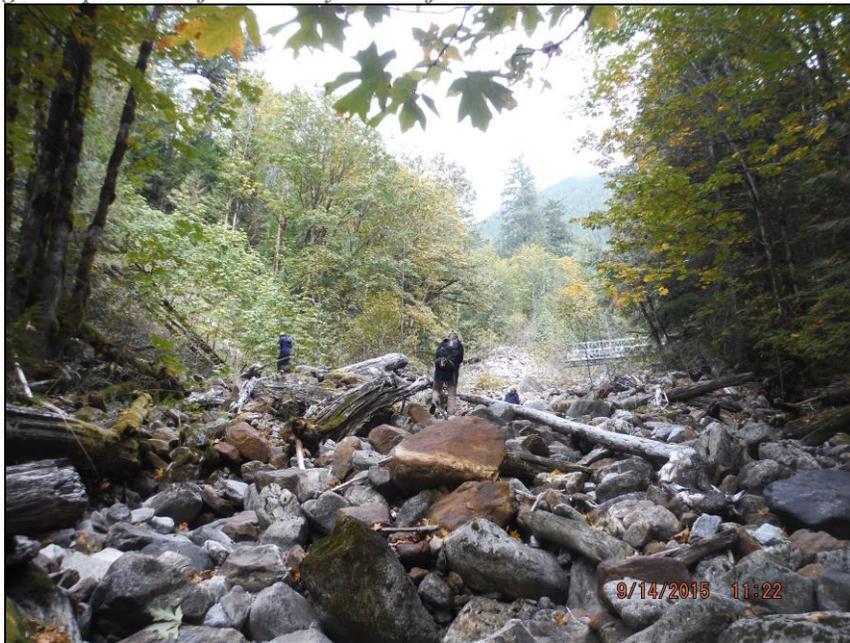
Figure 25. WCC hiking Boulder Creek, the delta of this creek was the only location where we found new knotweed patches from Newhalem to Copper Creek in 2015. Knotweed on this creek likely came from contaminated solid used by SCL to build the bridge shown in photo. Emphasizing the importance of keeping soil and gravel pits weed free as they are major vectors.

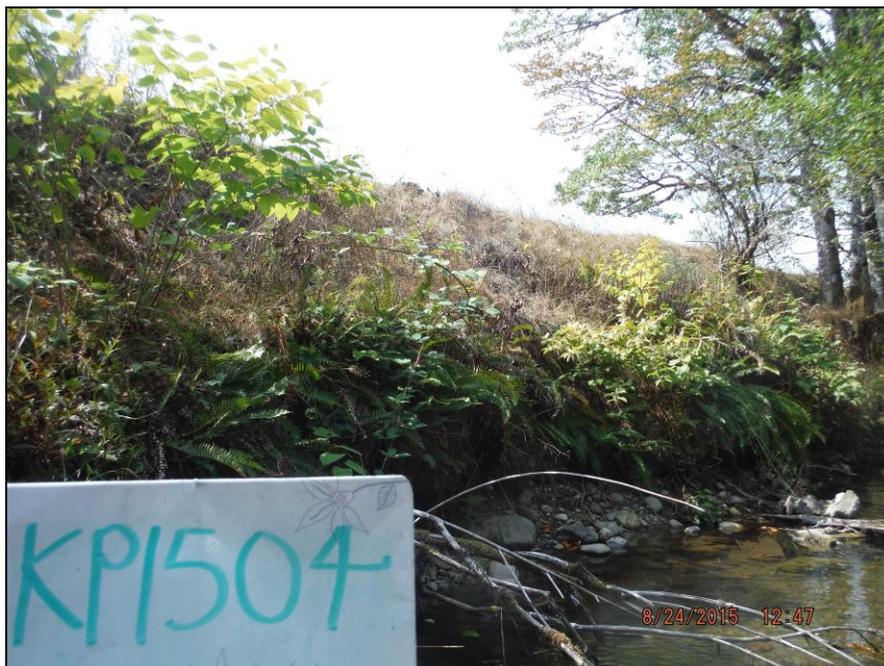
Figure 26. Patch KP1504, growing along the banks of Illabot Creek, a tributary of the Skagit River. SFEG surveys this tributary each year because it is a priority salmon stream for the federally listed Chinook Salmon. SFEG surveyed by foot 5 miles of Illabot Creek in 2015.
